CONSERVATION ASSESSMENT REPORT
and
RECOMMENDATIONS FOR METRO-OWNED PUBLIC ART
CITY OF NASHVILLE, TENNESSEE

Prepared For
Anne-Leslie Owens, Public Art Project Manager
Metro Arts Nashville

Prepared By
Andrew Smith, Principal
Smith Art Conservation, LLC

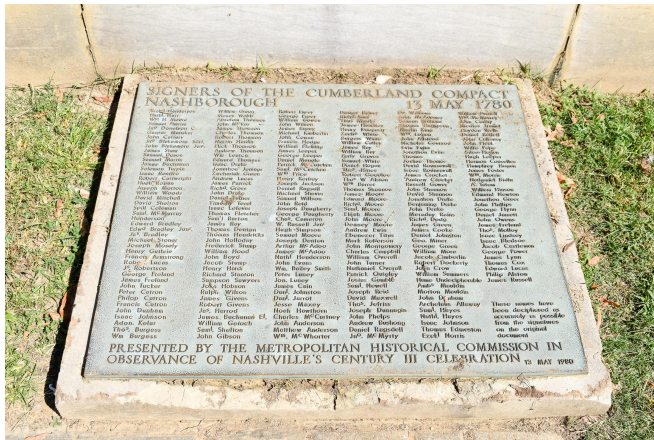
Fig. 1 - Ground plaque showing oxidation and concrete loss

- Removal and replacement of all mortar seams
- Biological growth removal and cleaning of all stone surfaces using D/2 Biological Solution
- In-situ concrete footer repair poured in place to achieve correct concrete form at in-ground plaque.

- Removal of failed coatings on plaques via hot pressure wash.
- Refinishing and sealing of all plaques to achieve uniform dark brown background with brass-toned raised lettering profile. A variety of methods can be utilized to achieve this result. (dry ice blasting, soda blasting, laser cleaning, or other gentle mechanical means). Surfaces to be coated with conservation-grade exterior non-yellowing lacquer clear coat system

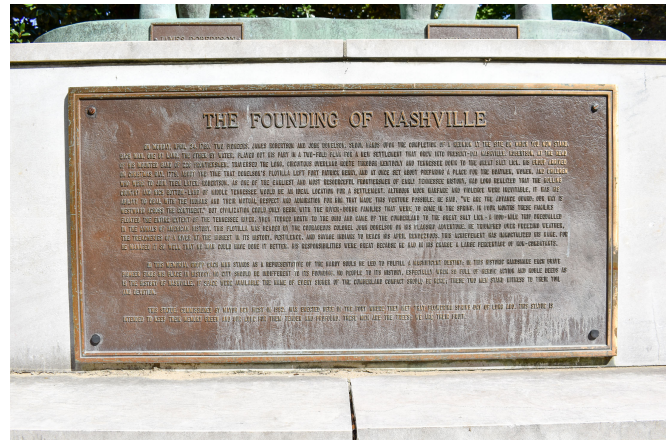
Fig. 2 - Plaque on sculpture base showing graffiti ghosting, failed lacquer.

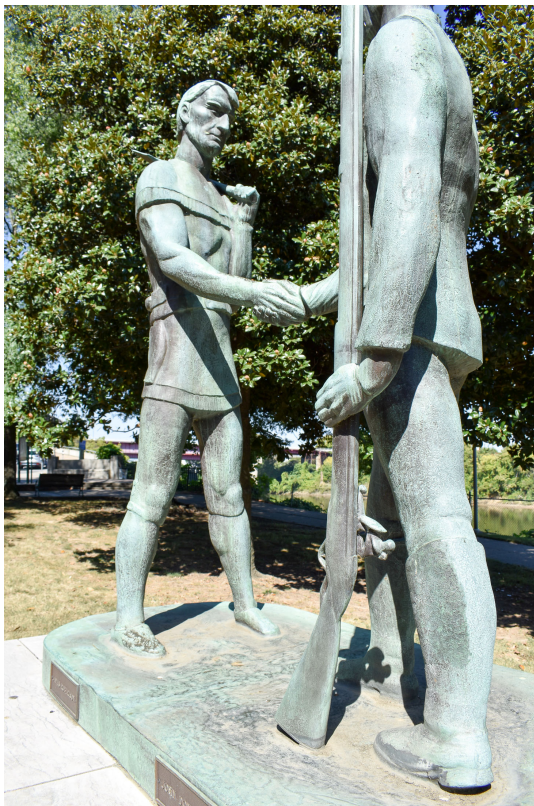
Fig. 3 - Verdigris corrosion staining and oxidation. Staining from pooled water around feet

- Oxidation / verdigris corrosion removal of bronze figures to establish surfaces ready for re-patination in historically accurate dark brown patina. Methods for preparation may require soda-blasting, dry ice blasting, or other safe method to not damage or etch bronze surfaces.

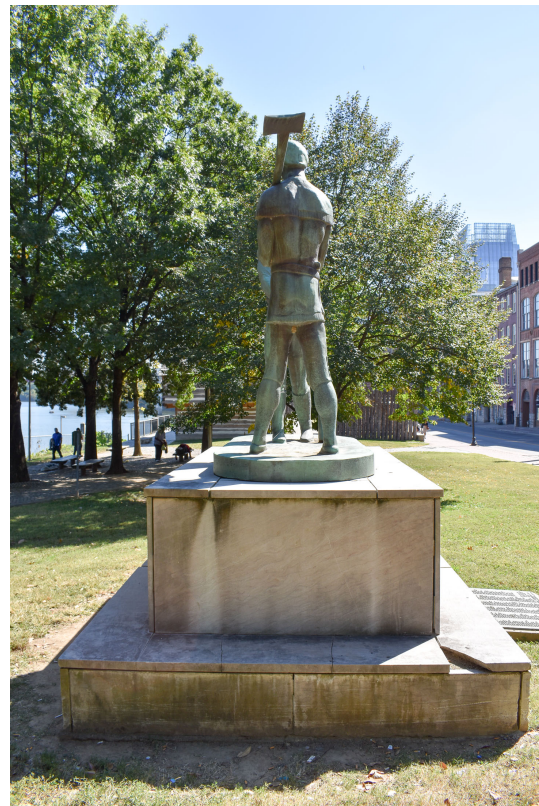
Fig. 4 - North vantage. Bio-staining on base, mortar losses, and verdigris corrosion on statues

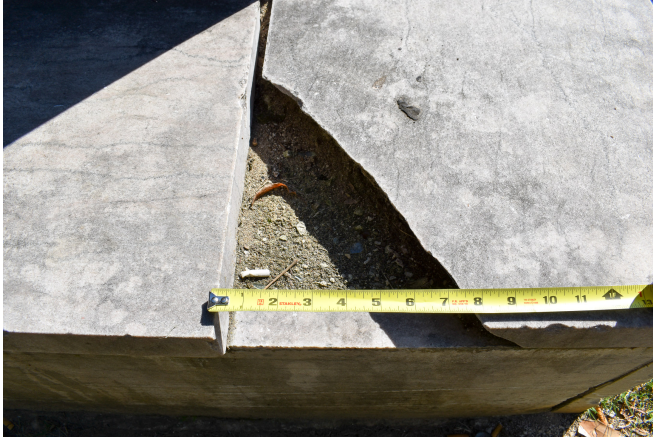
Fig. 5 - Extent of large loss on base

- Reset/realign slabs as necessary to achieve flat profile and correct in-plane structure.
- Repair / patch losses on the stone via dutchman repair using in-kind Tennessee marble correctly bonded to achieve seamless repair.

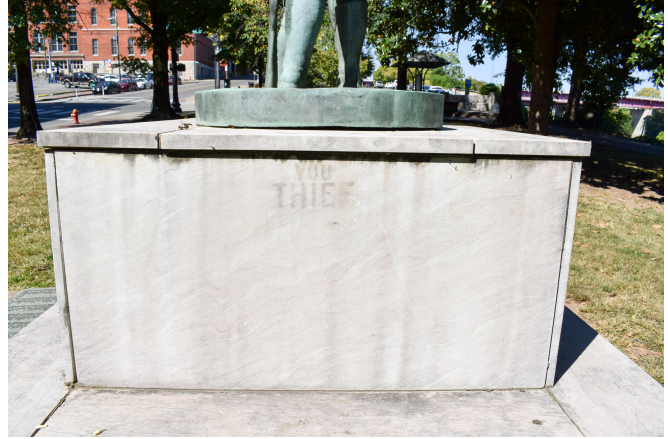
Fig. 6 - Mortar seam losses, staining, and ghost image of graffiti: "YOU THIEF"

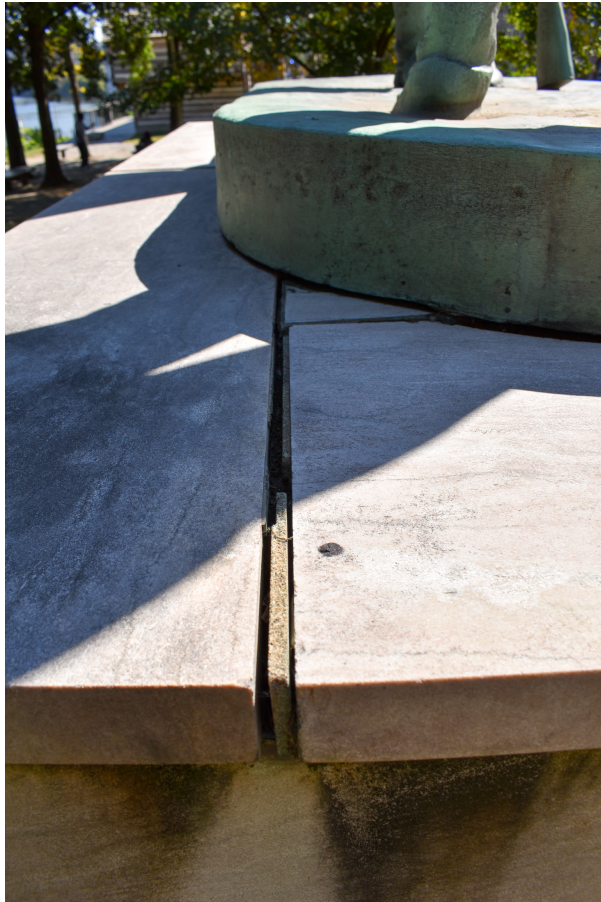
Fig. 7 - Typical losses and gaps in all seams between marble slabs

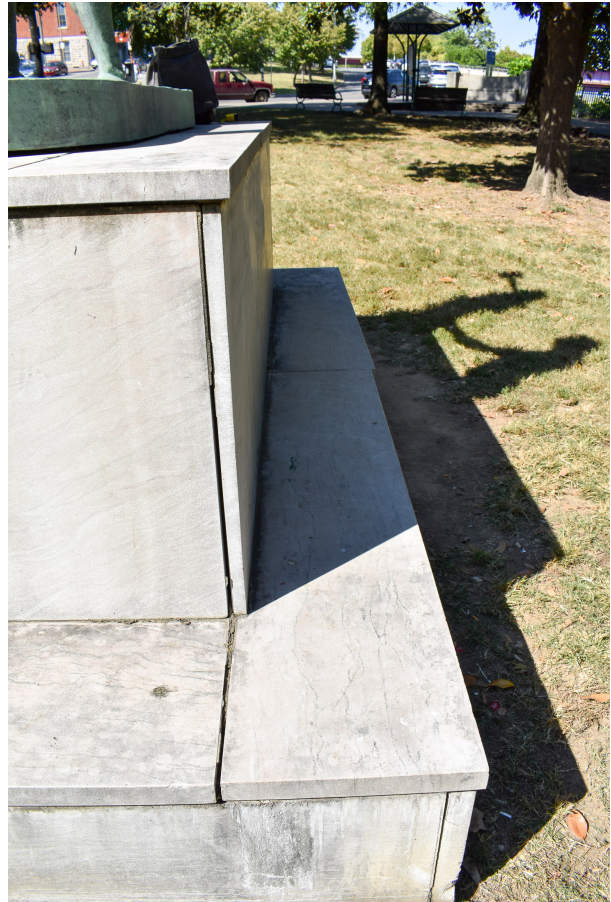
Fig. 8 - East face out of plane (lower tier). Bio staining on base, gouges from lawn mower, mortar losses

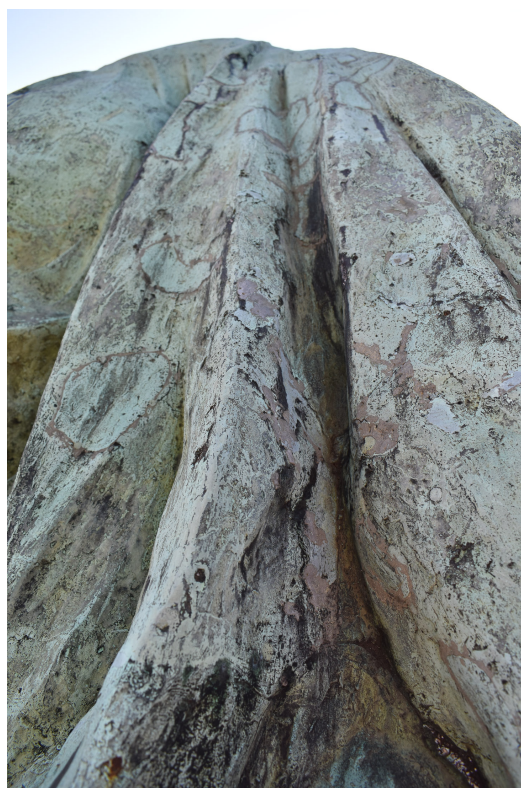
Fig. 4 - Detail of cape folds. Carbon
staining and unidentified circular "scars"

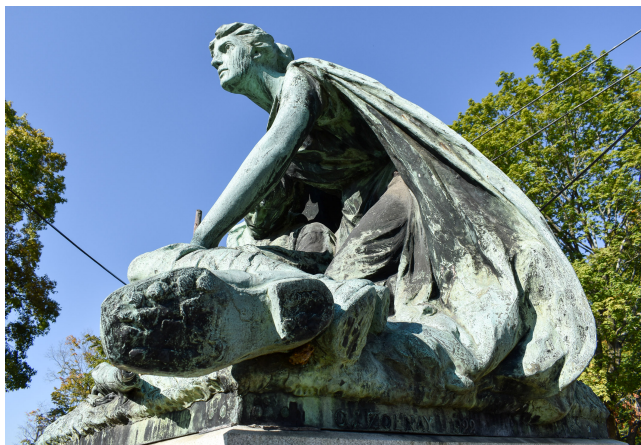
Fig. 9 - Heavy carbon staining

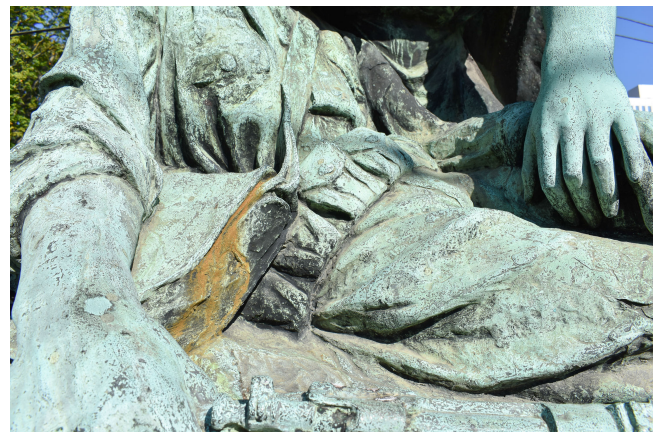
Fig. 10 - Verdigris corrosion and unidentified rust staining on satchel

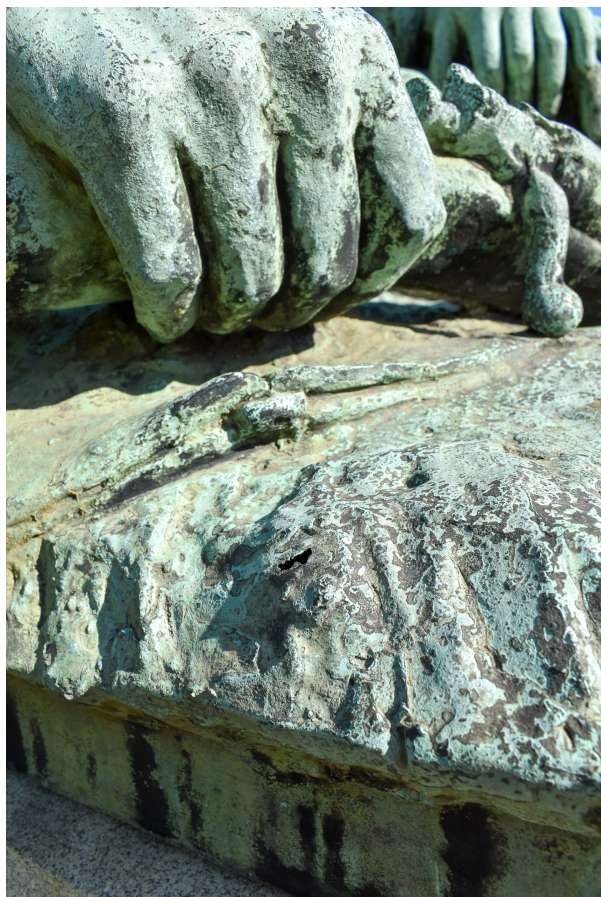
Fig. 11 - Small hole in the thin bronze /
embedded dirt in crevices

- Small hole in bronze repaired via patch welding. Weld should be performed using in-kind copper alloy (bronze) and mechanically shaped to match surface texture of adjacent surfaces

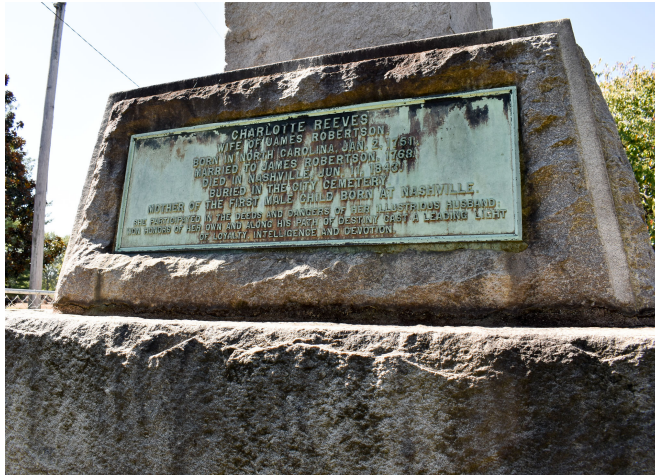
Fig. 5 - Plaque three showing verdigris and carbon crust. Bio staining on base

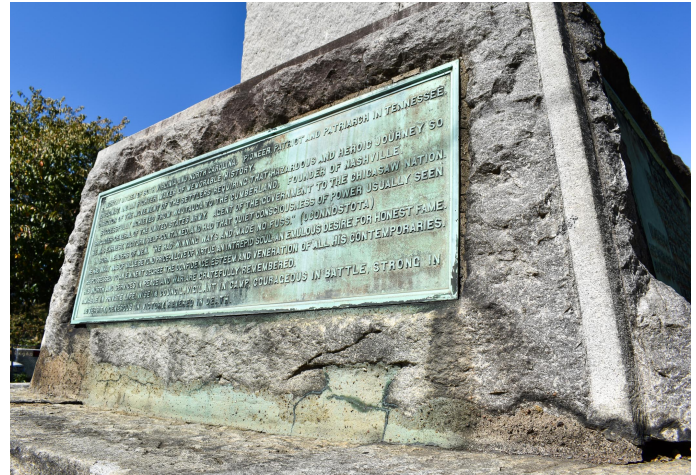
Fig. 6 - Plaque four showing verdigris runoff staining on mortar seams and fills

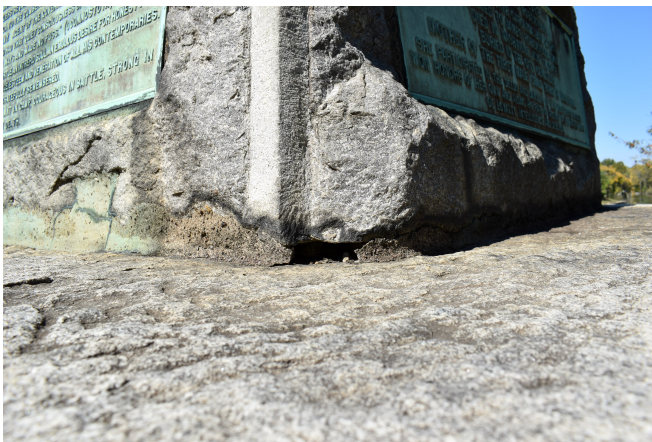
Fig. 7 - Mortar loss and staining

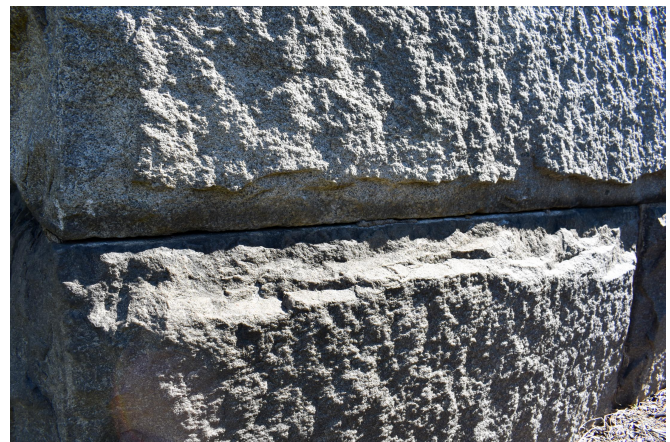
Fig. 8 - Mortar pointing loss (2' L section)

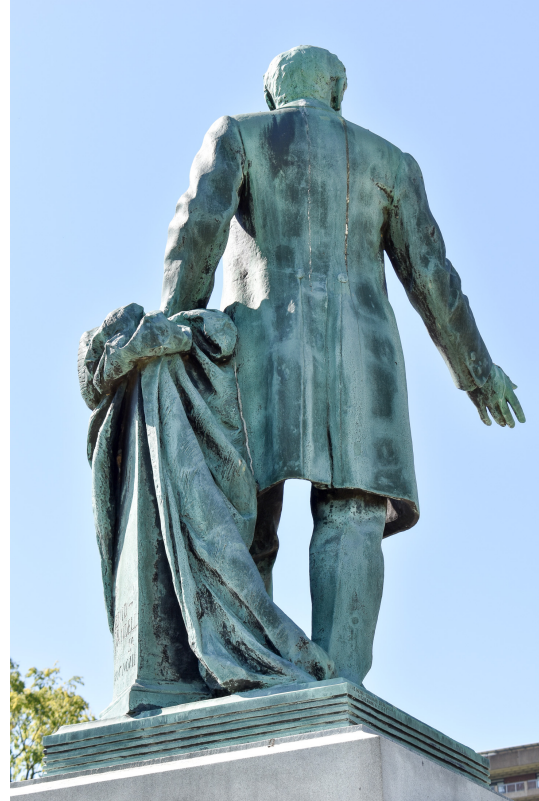
Fig. 4 - Back of figure. Heavy verdigris patina with uneven blotchy dark areas and carbon staining

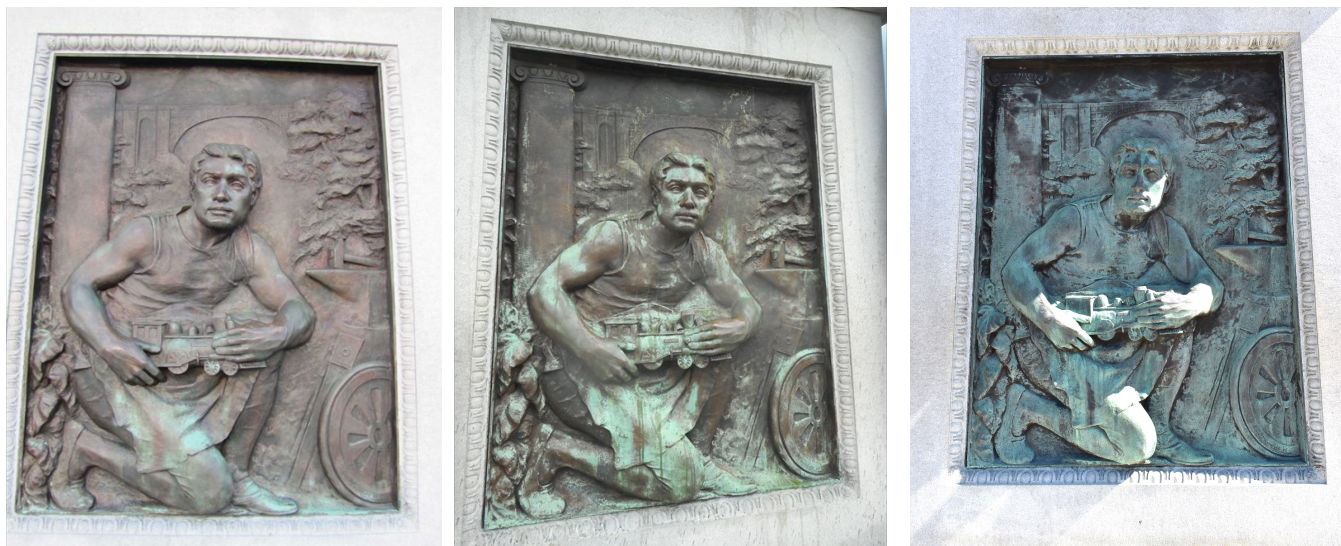
Fig. 7 - Bas-relief plaque as pictured (L to R) in 2013, 2015, and 2020 Deterioration of wax coating

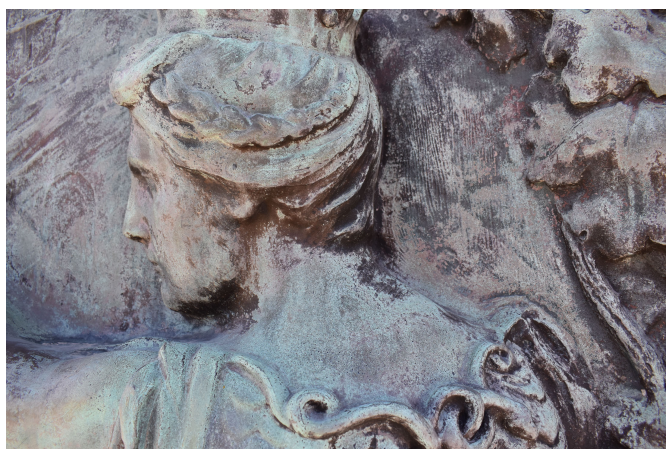
Fig. 8 - Bas-relief plaque patina detail

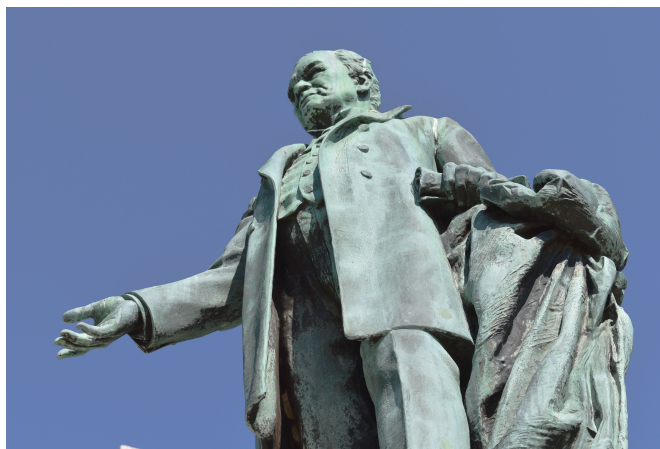
Fig. 9 - John Thomas verdigris staining

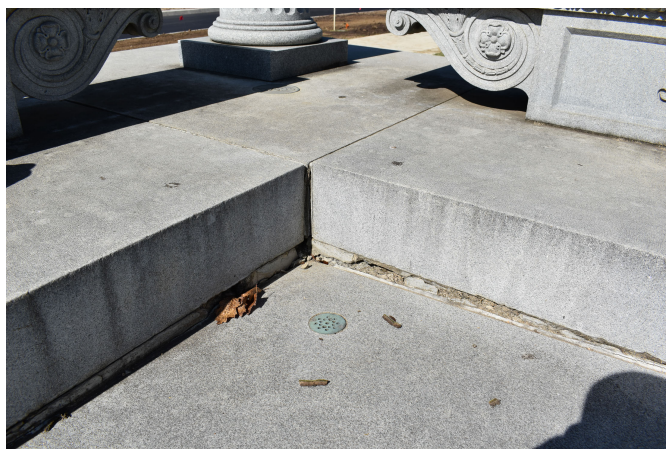
Fig. 10 - Concrete losses at corner

- Concrete substrate patching where losses are found
- Mortar repointing to match existing seams on interior and exterior surfaces
- Drainage cap replacement as needed on flooring corners

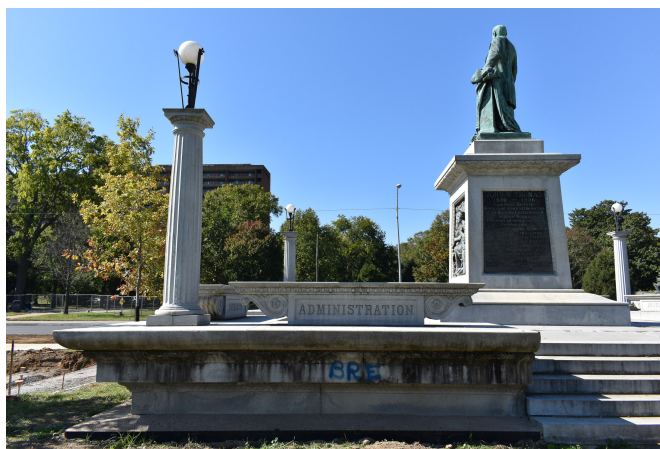
Fig. 11 - Bio staining and graffiti on ledge

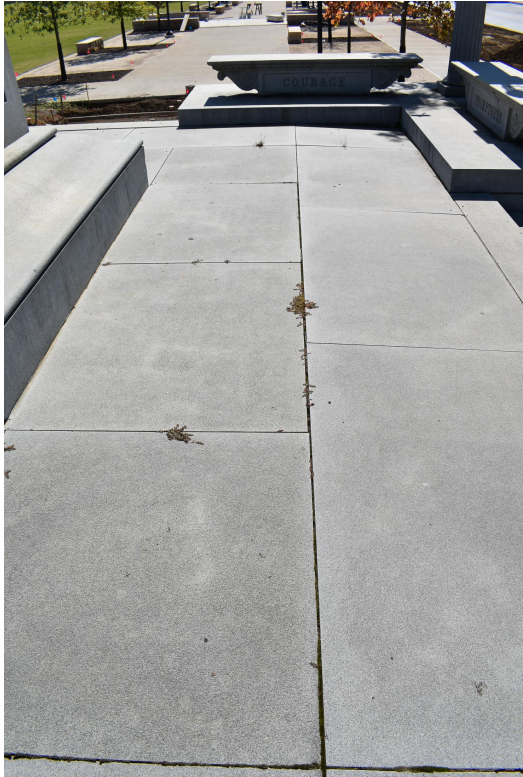
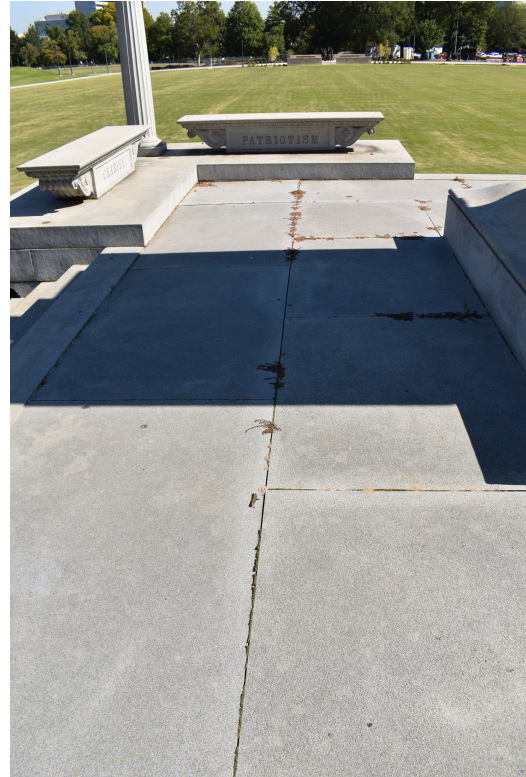
Fig. 12 + 13 Seam losses/plant growth in cavities throughout flooring

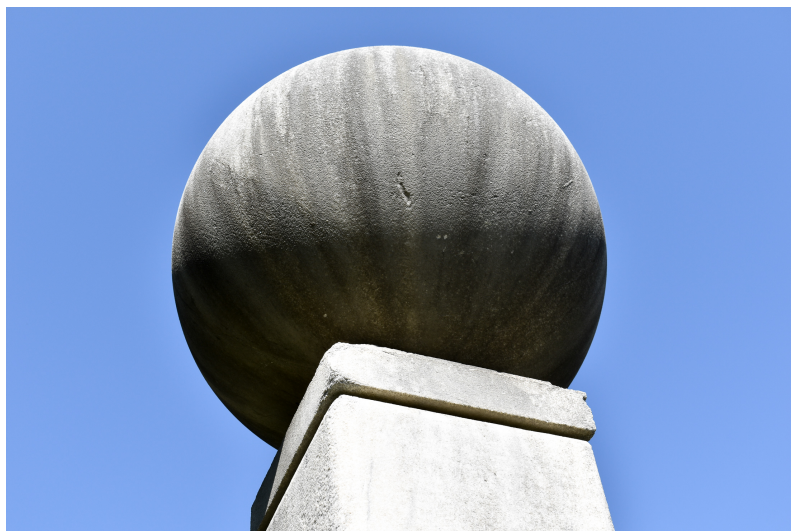
Fig. 1 - Dark biological staining on globe, and small losses at corners

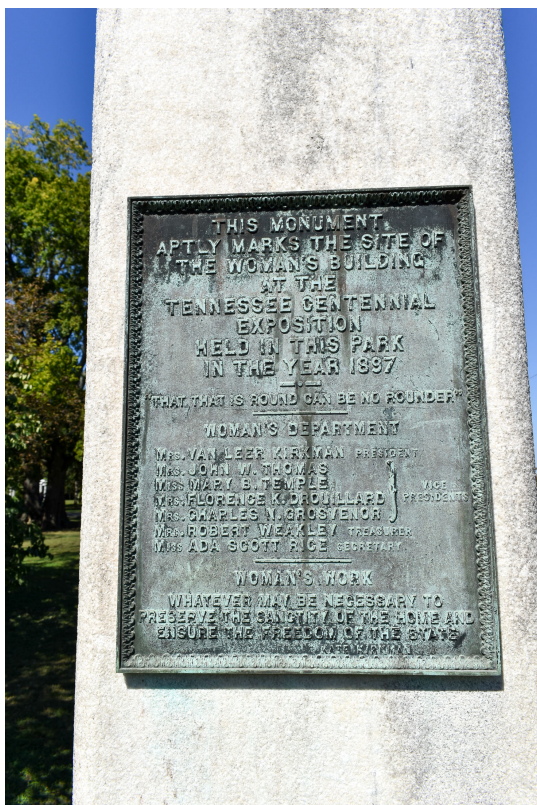
Fig. 2 - Corrosion and oxide staining from plaque deterioration

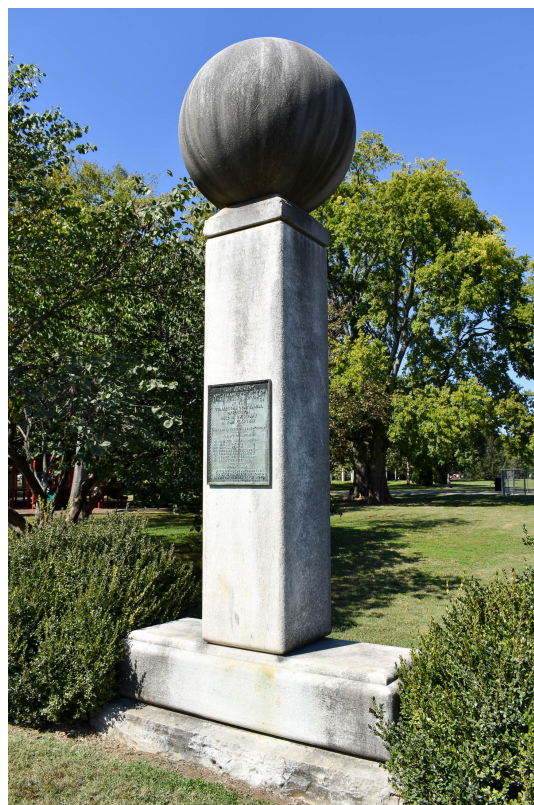
Fig. 3 - Biological staining, oxide runoff on lower portion of base

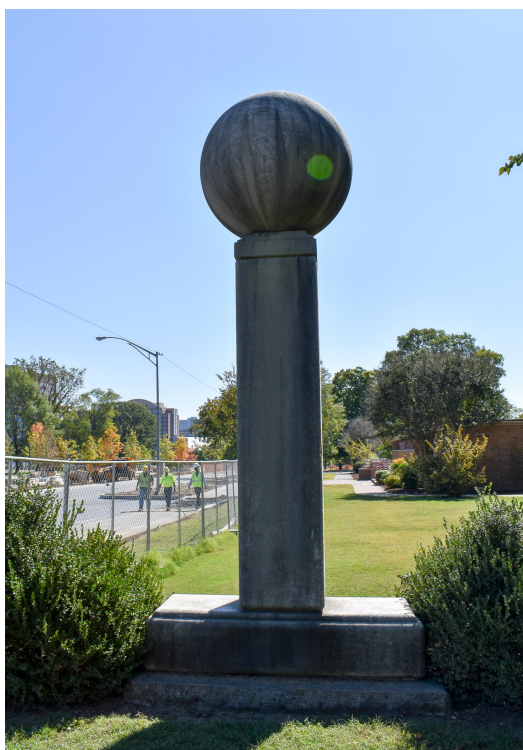
Fig. 4 - Biological staining on all surfaces

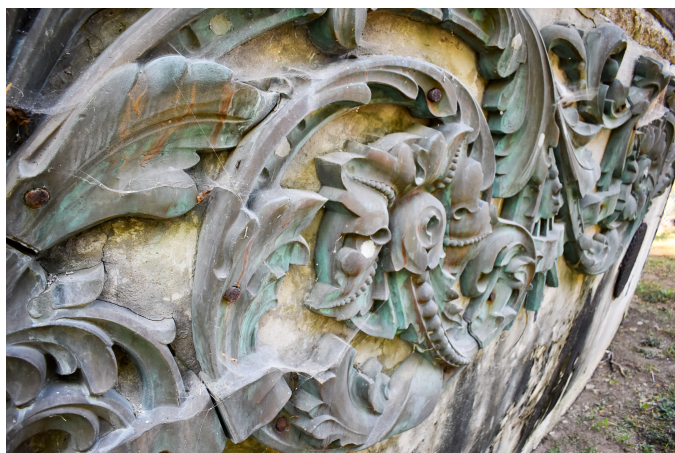
Fig. 3 - Iron rods - both varieties: exposed and capped with concrete. Residual paint staining

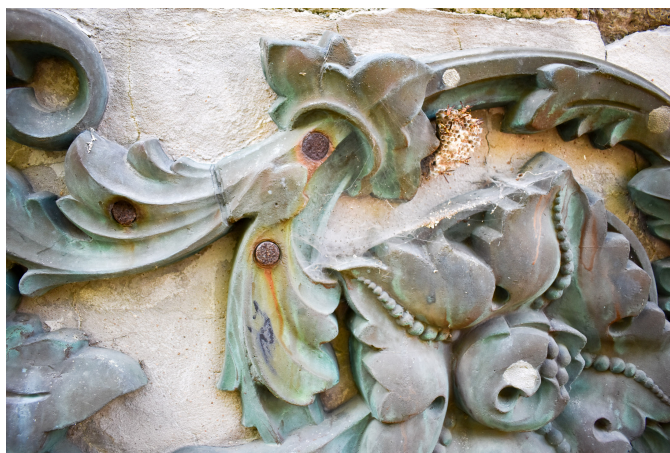
Fig. 4 - Detail showing corrosion staining from iron, light brown paint drips. Wasp nest

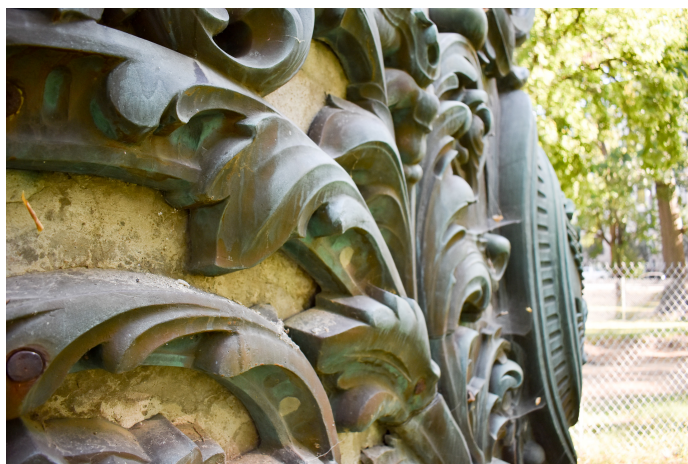
Fig. 5 - Detail showing corrosion staining from iron, light brown paint drips, debris and verdigris

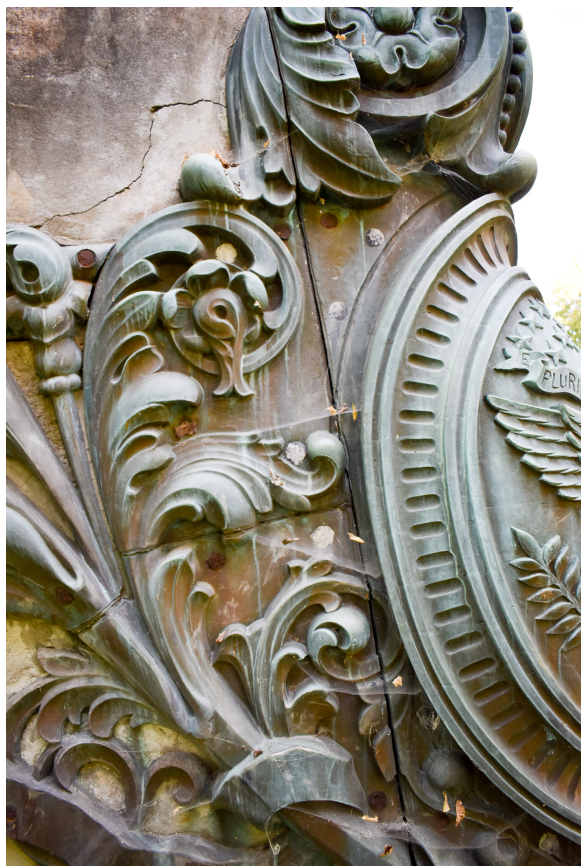
Fig. 6 - Detail showing corrosion staining from iron, light brown paint drips, and joining of sections

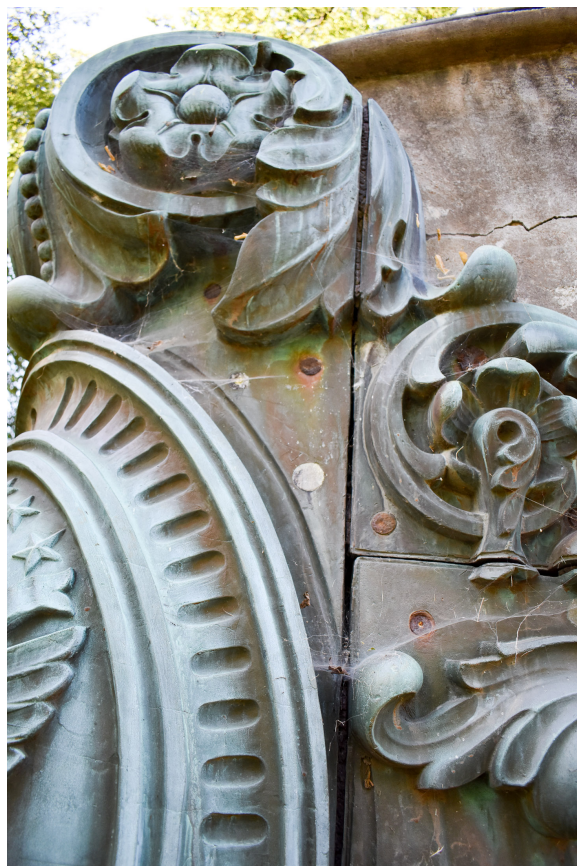
Fig. 7 - Detail showing corrosion staining from iron, light brown paint drips, and joining of sections

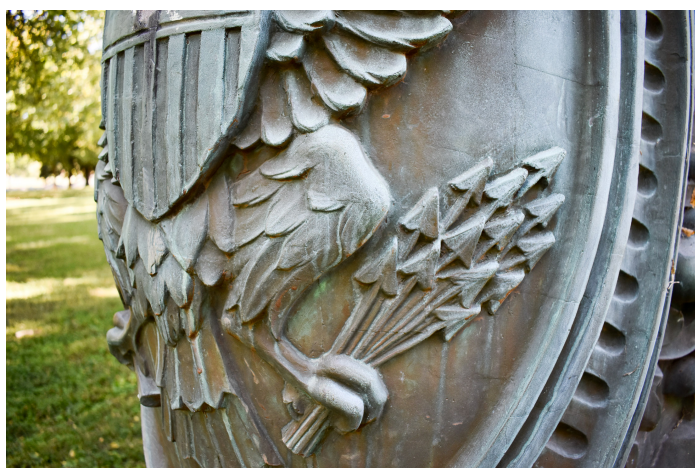
Fig. 8 - Detail from crest. Small deposits of light brown coating evident in several areas

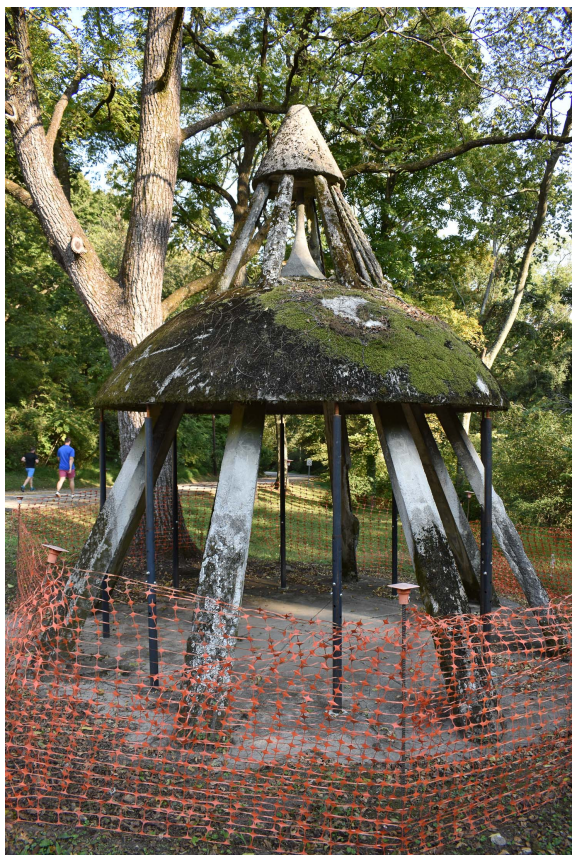
Fig. 1 - Overall vantage showing heavy moss and lichen growth on dome. Shoring posts aiding in structural support

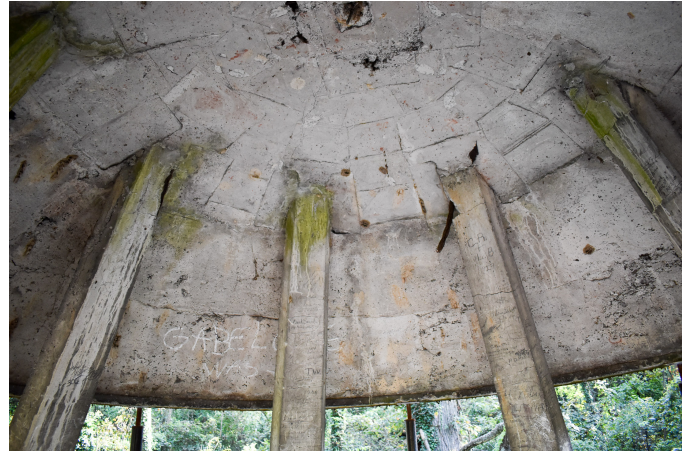
Fig. 4 - Dome underside opposite vantage. Rebar protruding through upper pillar. Losses, staining, and biological growth

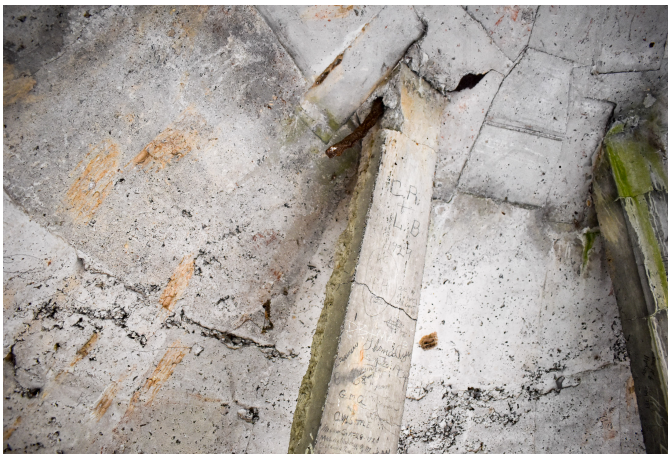
Fig. 5 - Detail of exposed rebar damage, historic graffiti on pillar, and fracture. Numerous air pockets from fabrication within concrete

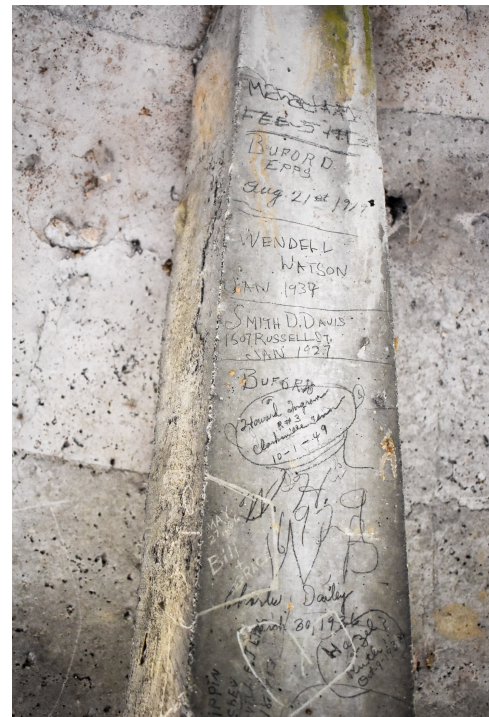
Fig. 6 - Detail of historic graffiti dating to 1913

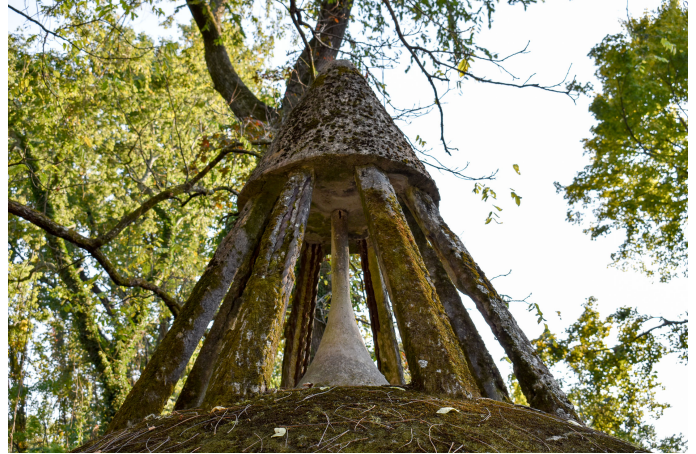
Fig. 9 - Upper cone section. Multiple areas of exposed rebar and partially intact pillar structures, fractures possibly hidden due to moss growth.

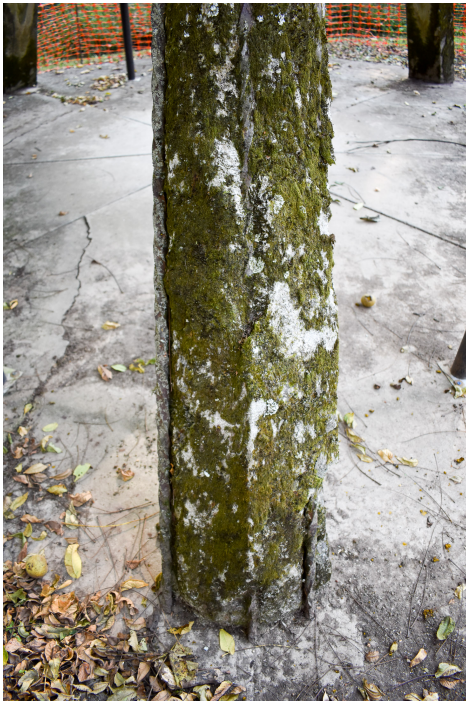
Fig. 10 - Lower pillar section. Exposed rebar, heavy biological growth.

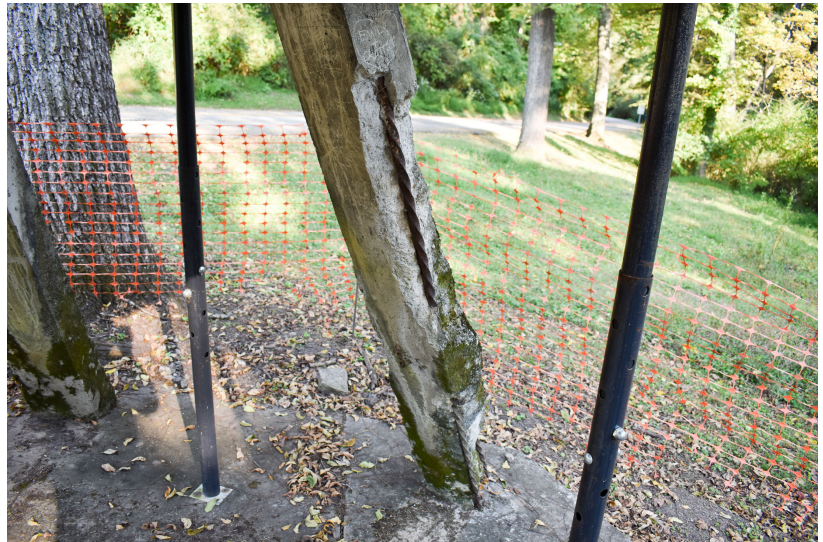
Fig. 11 - Large sections of loss on pillar exposing rebar sections. Shoring posts aiding in support

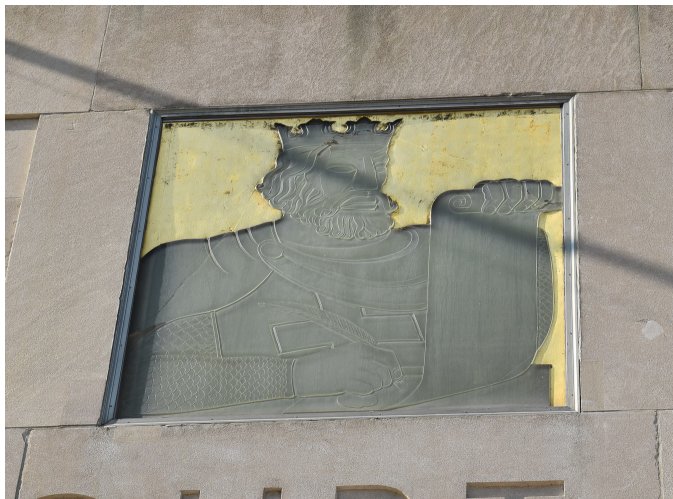
Fig. 3 - King John. Gold leaf deterioration along top edge.

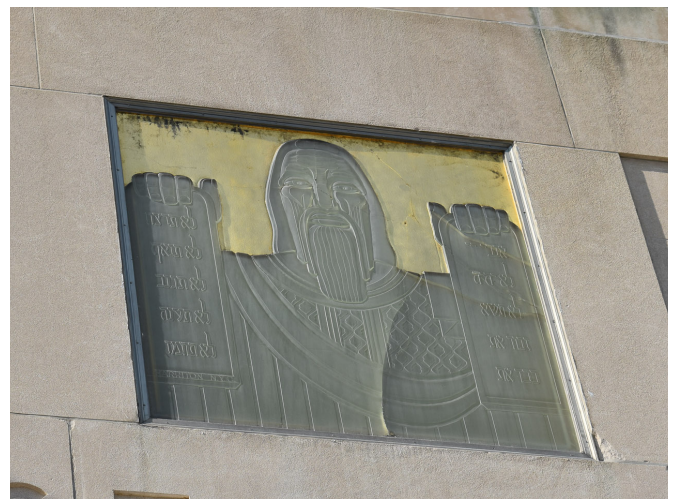
Fig. 4 - Moses. Large, curved crack from right shoulder to sternum - repaired. Gold leaf deterioration. Limestone loss on lower right corner

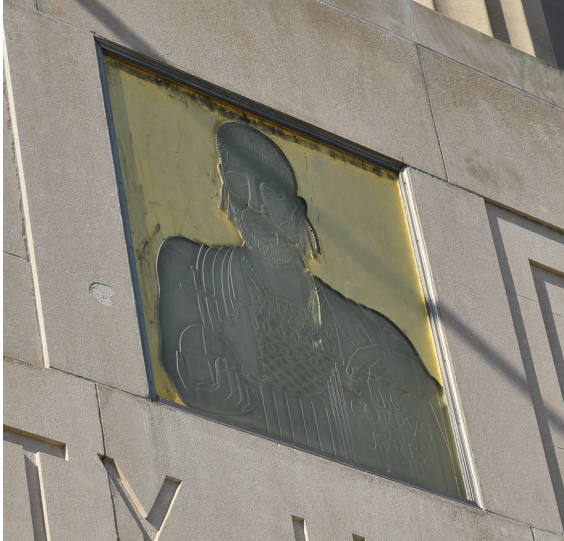
Fig. 5 - Justinian. Gold leaf deterioration along top edge.

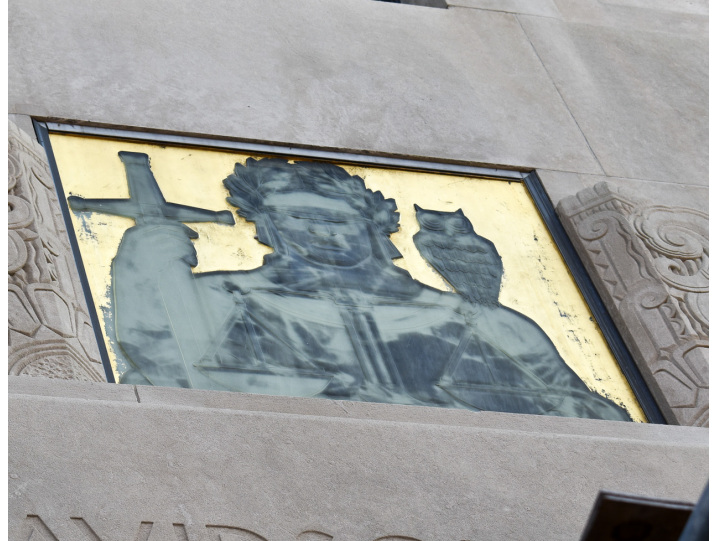
Fig. 6 - Justice. Gold leaf deterioration, severe marring from internal adhesive residue.

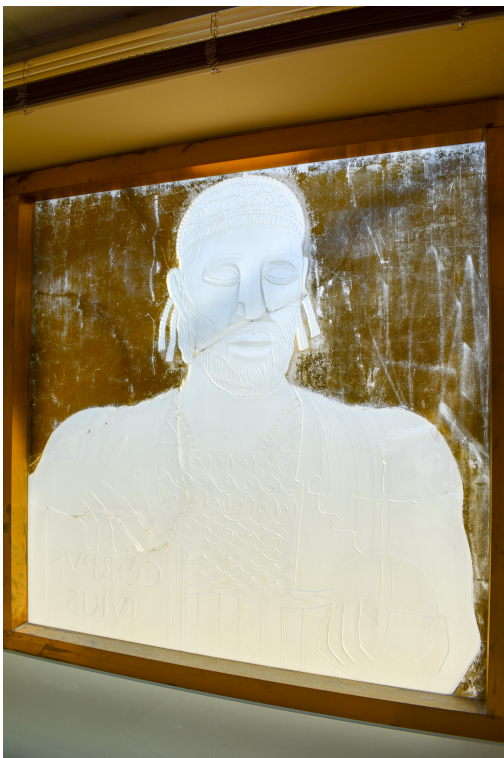
Fig. 7 - Justinian. Interior. Gold leaf deterioration (squiggles suggest pressure washing on exterior)

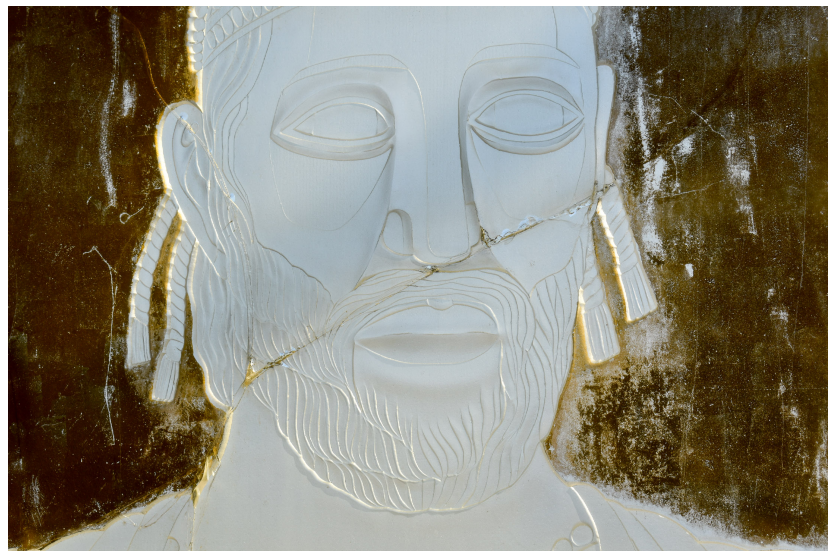
Fig. 8 - Justinian. Detail showing fractures, spalling at the fracture edges, and yellowed fill material on lower left jaw line.

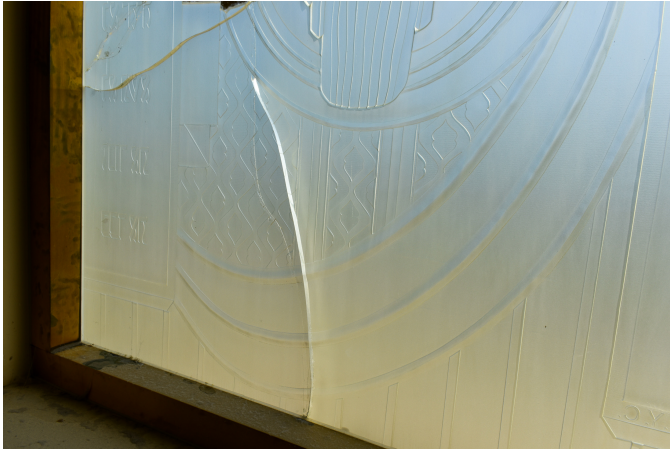
Fig. 8 - Moses interior showing larger fracture (see fig. 4 for exterior) Oxidation and staining on copper alloy framing

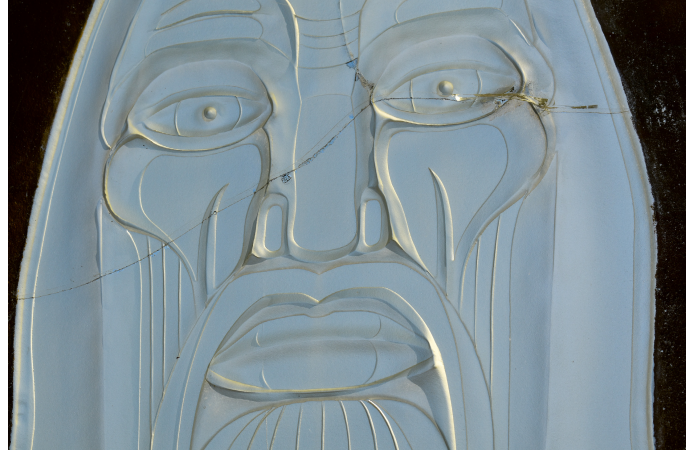
Fig. 9 - Moses interior detail showing network of cracks, corresponding spalling, and loss of "frosted" appearance in larger spalls

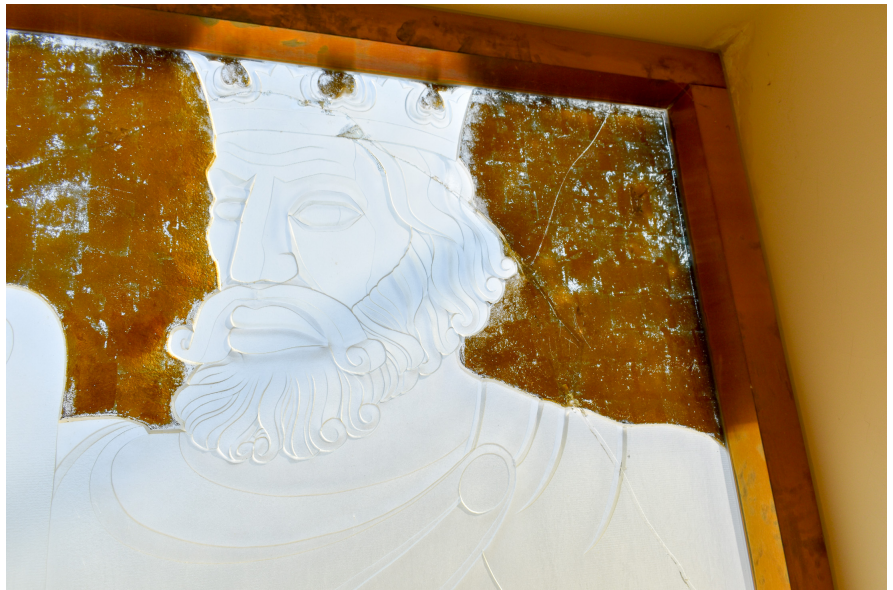
Fig. 11 - King John detail showing crack network, spalling in the crown area, gold leaf deterioration, oxidation on copper alloy, and water staining in drywall upper right corner. Further investigation is needed to find source of water ingress.

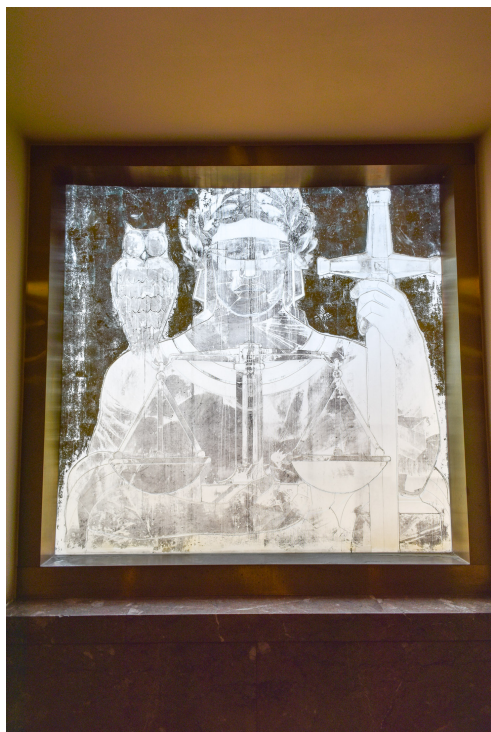
Fig. 12 - Overall interior vantage of "Justice" showing adhesive residue

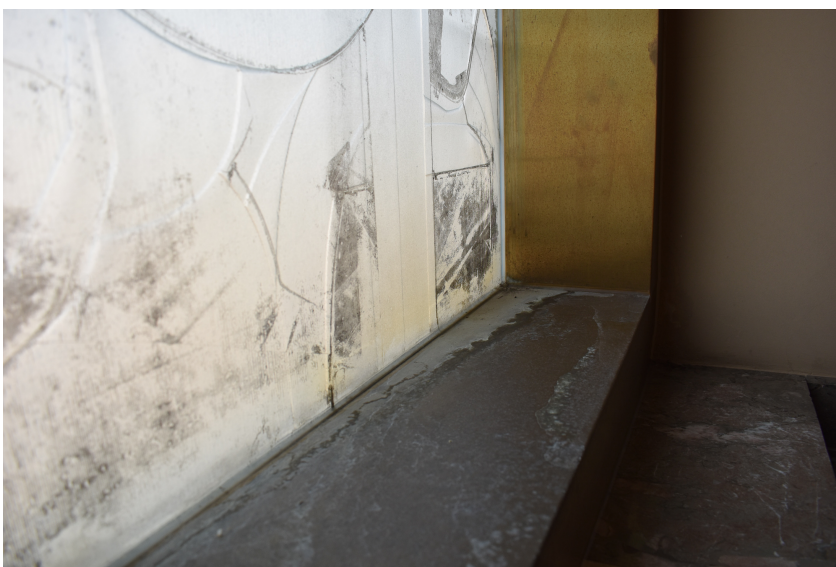
Fig. 14 - Detail of white liquid staining on copper alloy framing.
