CONSERVATION ASSESSMENT REPORT
and
RECOMMENDATIONS FOR METRO-OWNED PUBLIC ART
CITY OF NASHVILLE, TENNESSEE

Prepared For
Anne-Leslie Owens, Public Art Project Manager
Metro Arts Nashville

Prepared By
Andrew Smith, Principal
Smith Art Conservation, LLC

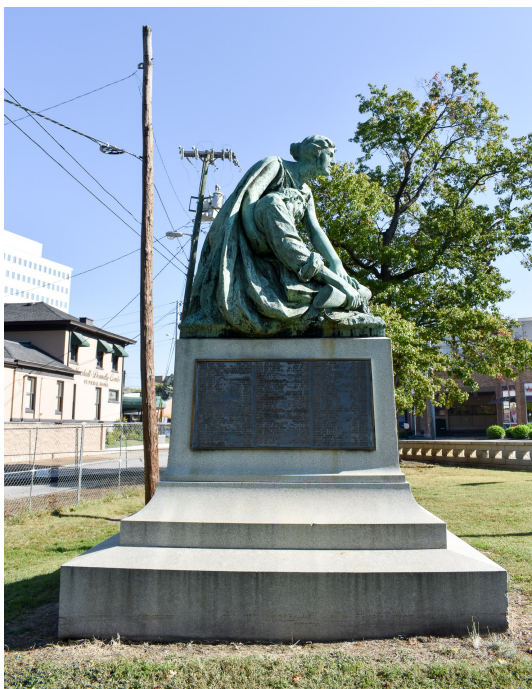
Fig. 1 - Overall vantage / left side

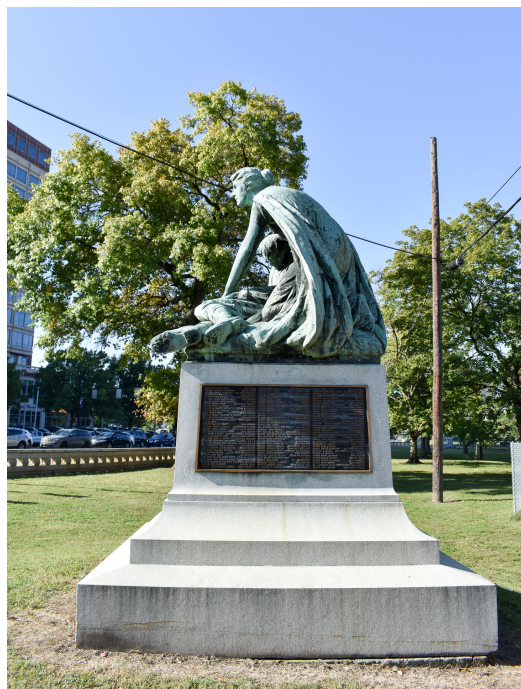
Fig. 2 - Overall vantage / right side

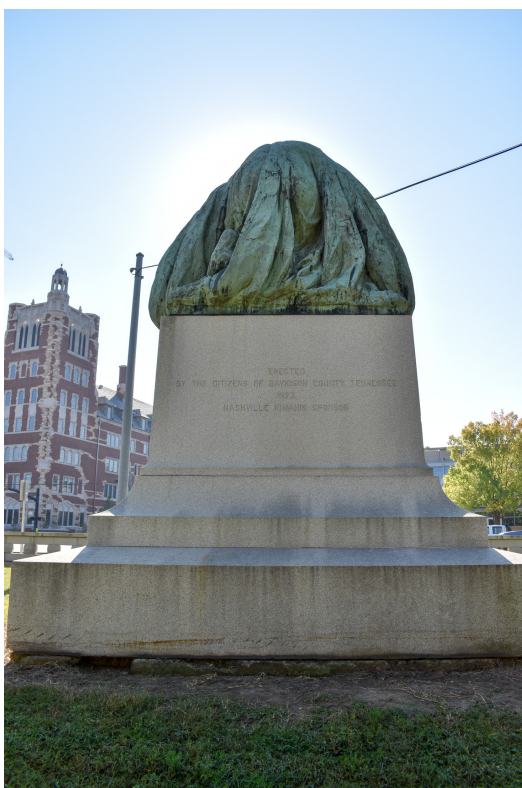
Fig. 3 - Overall vantage / back.
Concrete footer exposed, abrasions
visible on lower stone

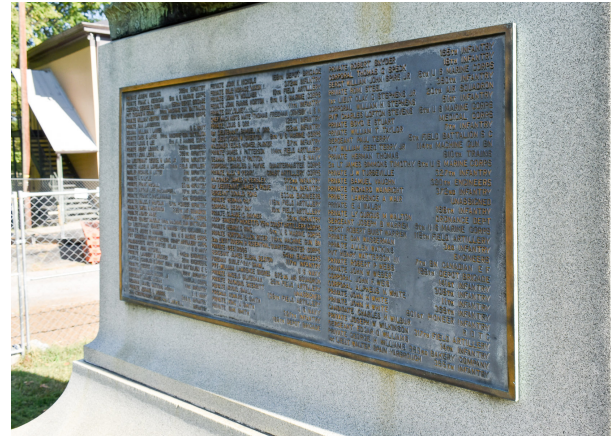
- **Plaques** - Both plaques have received restoration in the past, however the current clear coat system is no longer effective, has begun blistering and appears blanchd. Streaky horizontal white discoloration may be evidence of pressure washing, or simply failed clear coat application via spray which has thinned out. Gold lettering and outline border are tarnished and require restoration.

Fig. 6 - Plaque / left side showing failed lacquer.

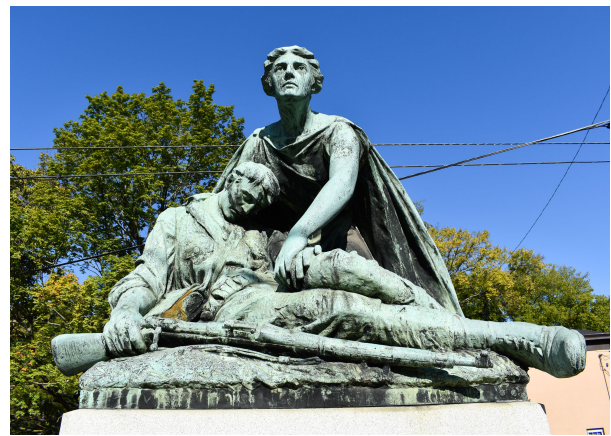
- **Bronze figures** - the bronze surfaces are heavily oxidized with bright green verdigris corrosion staining (the corrosion is not powdery and stable on surfaces). The bright green is further emphasized visually through the contrast of black carbon staining embedded within failed coatings in all unexposed areas, crevices, and folds. Crazeing is evident on blackened areas which indicates a coating system in an advanced state of deterioration. Dirt dauber and wasp nests are present in protected crevices and folds within the sculpture in addition to dust and debris lodged and embedded on surfaces. A small hole is found on the bronze beneath the soldier's proper right hand where the bronze is thin. Lead seams at intersection of bronze and granite are 10% intact.

Fig. 8 - Bronze figures / verdigris corrosion

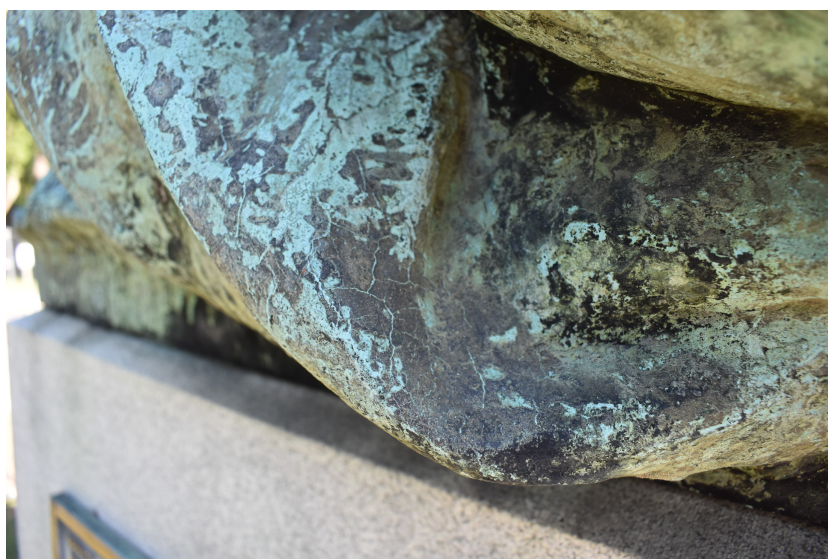
Fig. 12 - Crazing visible on what
appears to be evidence of previous
surface coating currently appearing
as black - also seen in Fig. 11

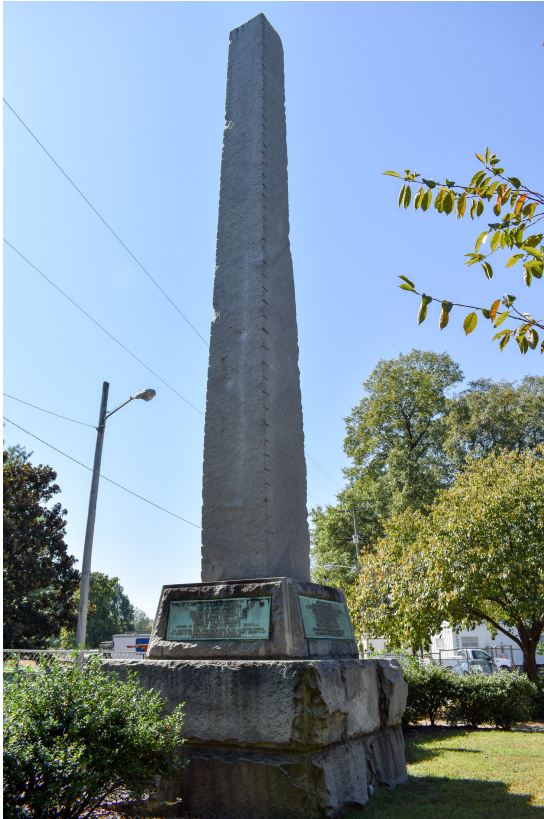
Fig. 1 - Overall vantage

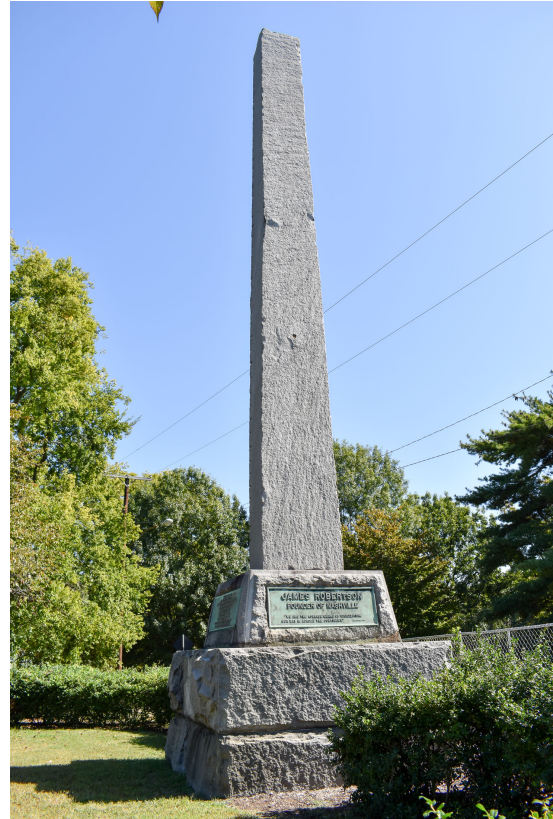
Fig. 2 - Overall vantage / opposite side

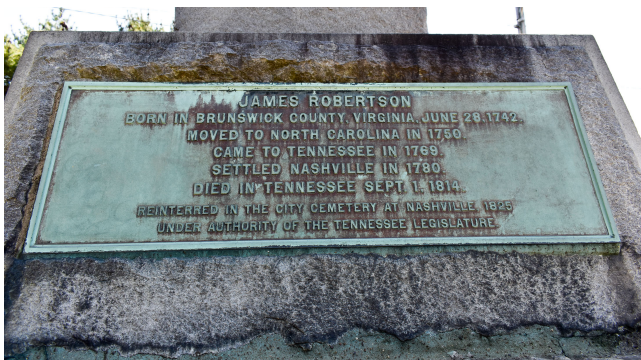
Fig. 3 - Plaque one with verdigris staining

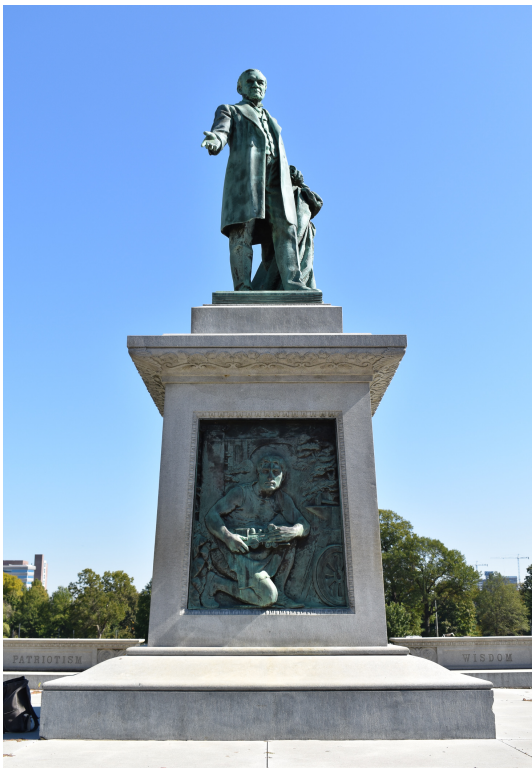
Fig. 1 - Vantage facing front

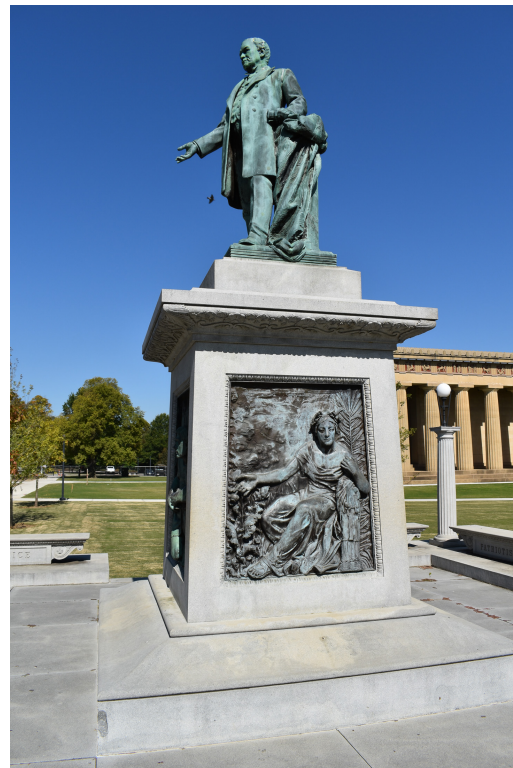
Fig. 2 - Vantage side - granite loss on base corner

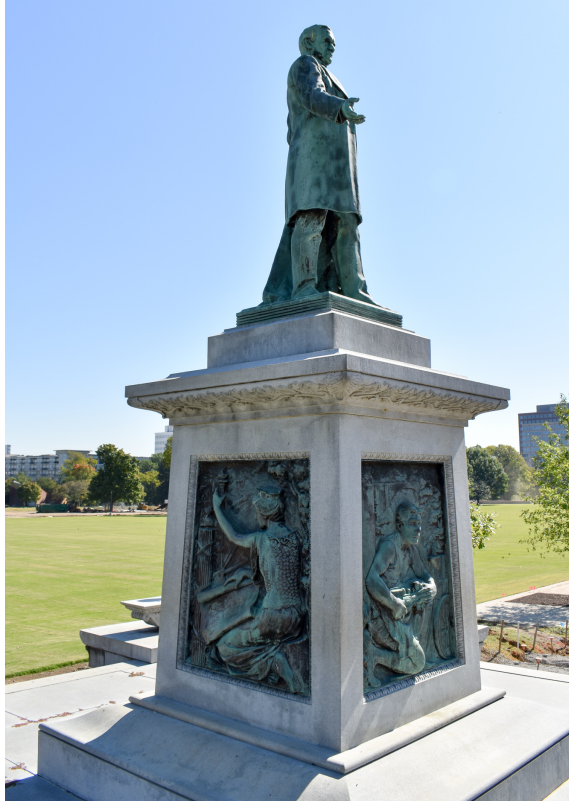
Fig. 3 - Vantage showing two of three bas-relief

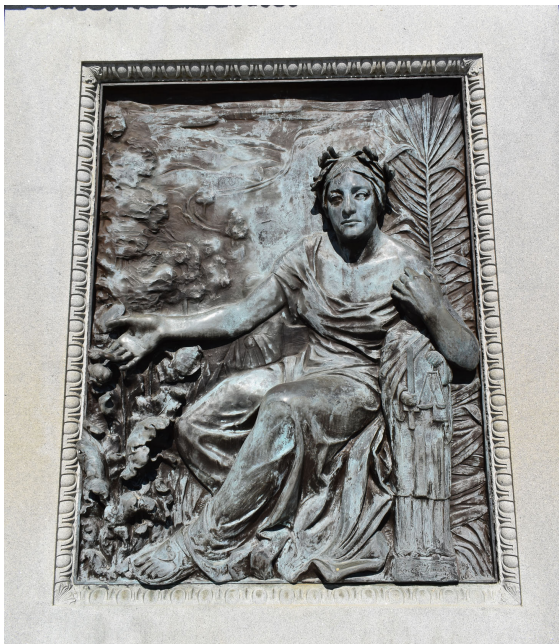
Fig. 5 - Bas-relief plaque

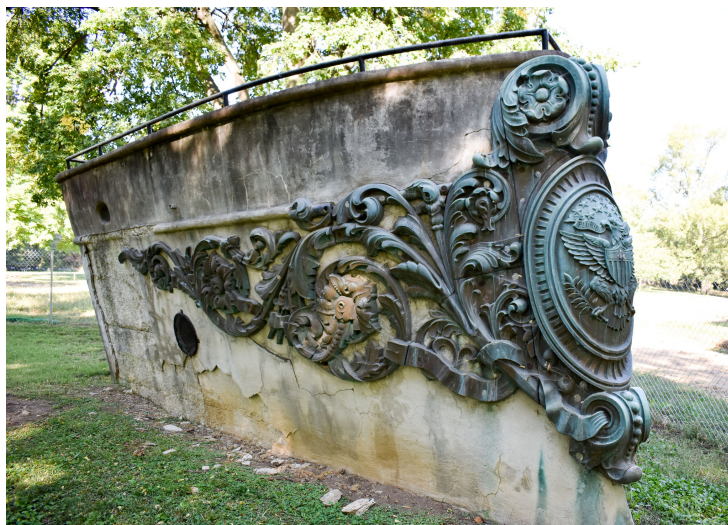
Fig. 1 - Vantage from left side

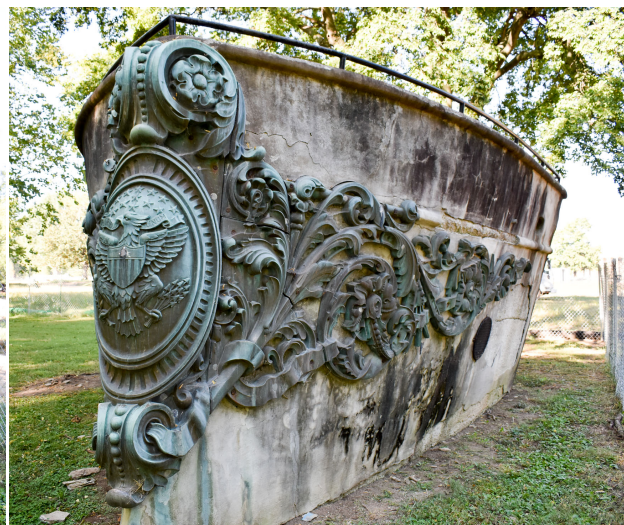
Fig. 2 - Vantage from right side

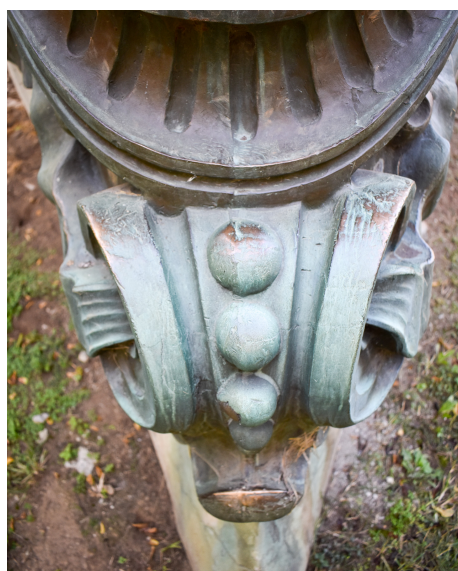
Fig. 8 - Detail from crest - worn patina from climbing

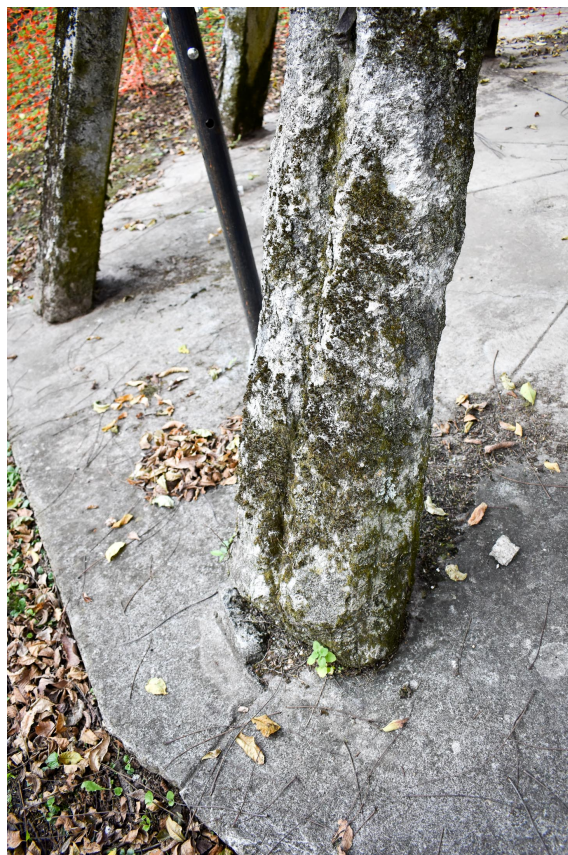
Fig. 2 - Heavy biological growth development and rebar segment loss (rebar intended to fit in channel slot)

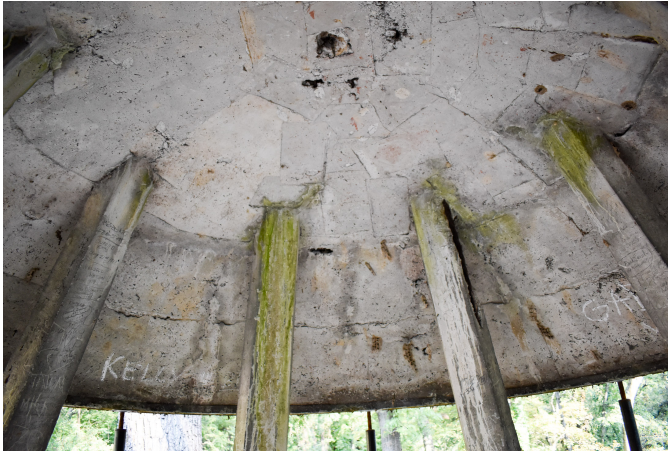
Fig. 3 - View of dome underside showing losses, exposed rebar and graffiti

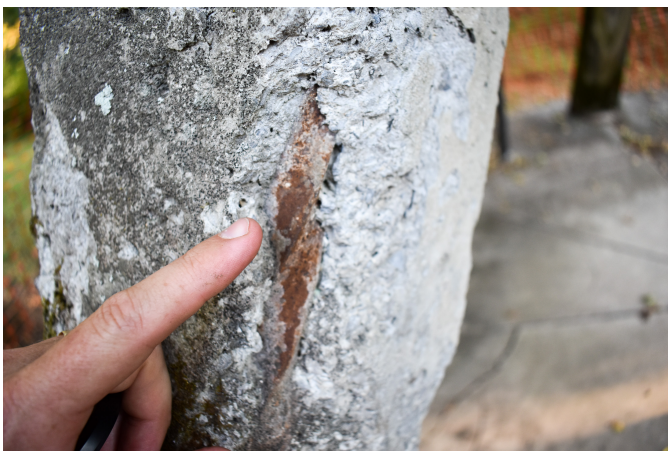
Fig. 7 - Detail to show scale of an exposed rebar section of pillar mid-point

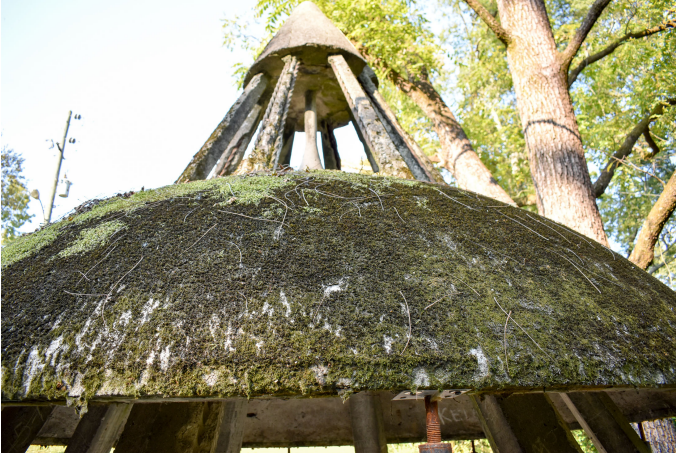
Fig. 8 - Heavy moss and lichen growth on outer dome. Exposed rebar sections on upper pillars.

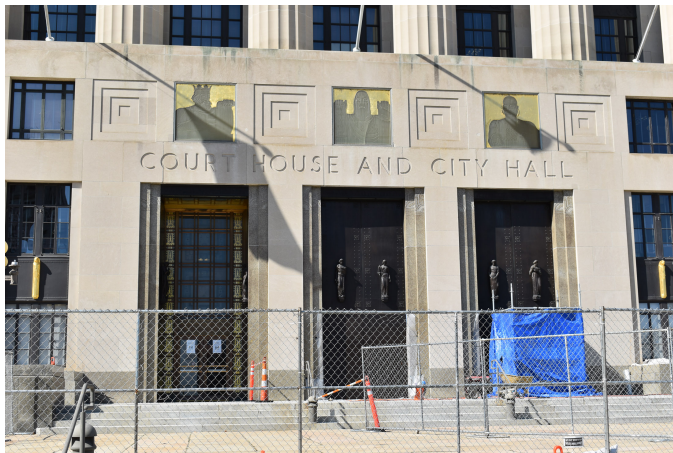
Fig. 1 - South facade vantage: King John, Moses and Justinian (L to R)

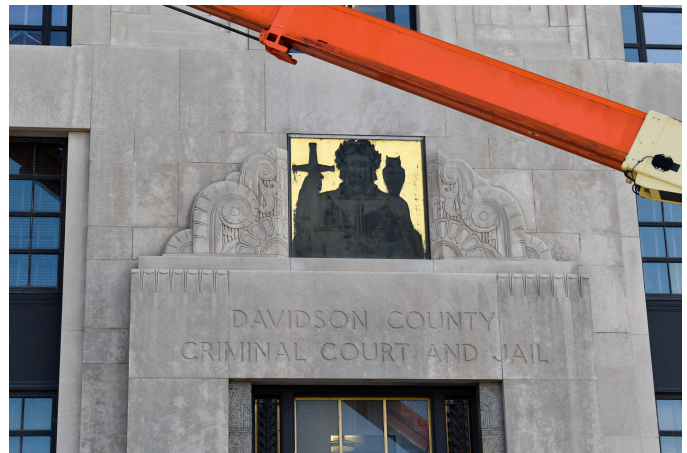
Fig. 2 - South facade vantage: Justice

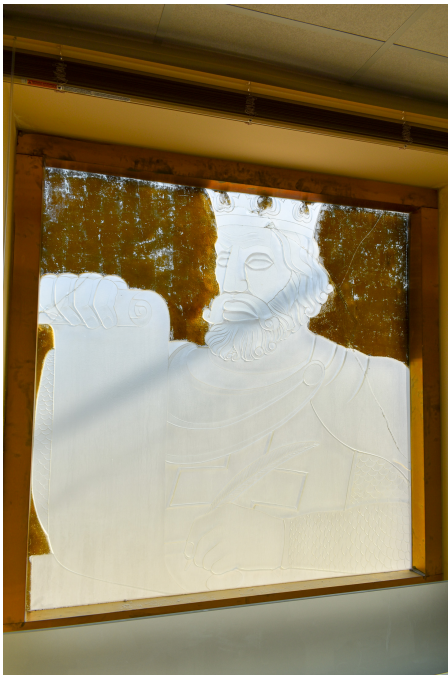
Fig. 10 - Overall interior vantage of King John

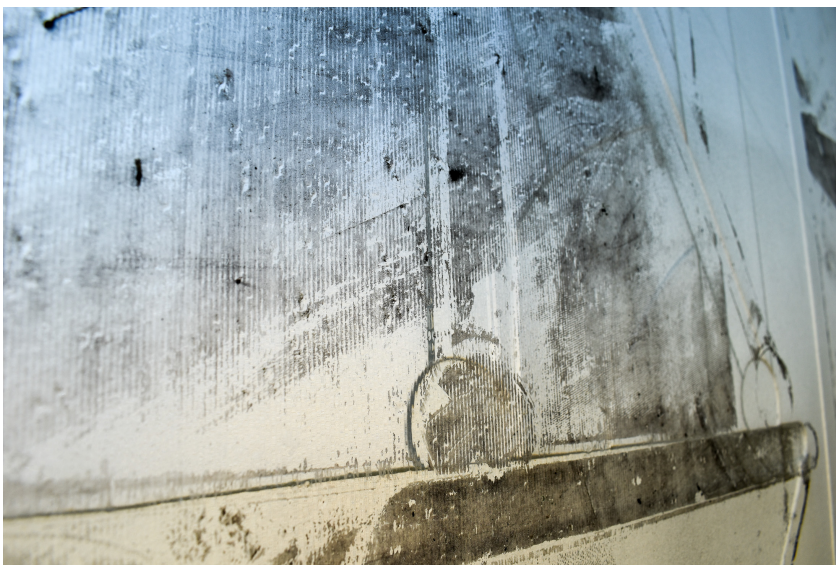
Fig. 13 - Detail of adhesive residue patterning

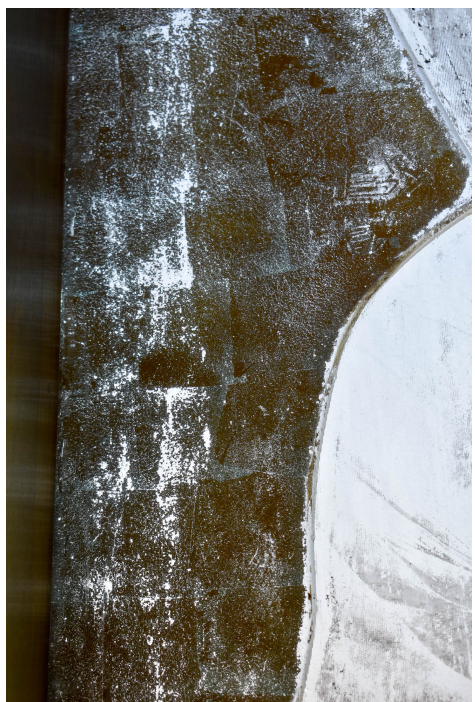
Fig. 15 - Detail of gold leafing losses
